The Tree Man

TREE MANAGEMENT REPORT

3 South Street, Strathfield

Design Link Australia

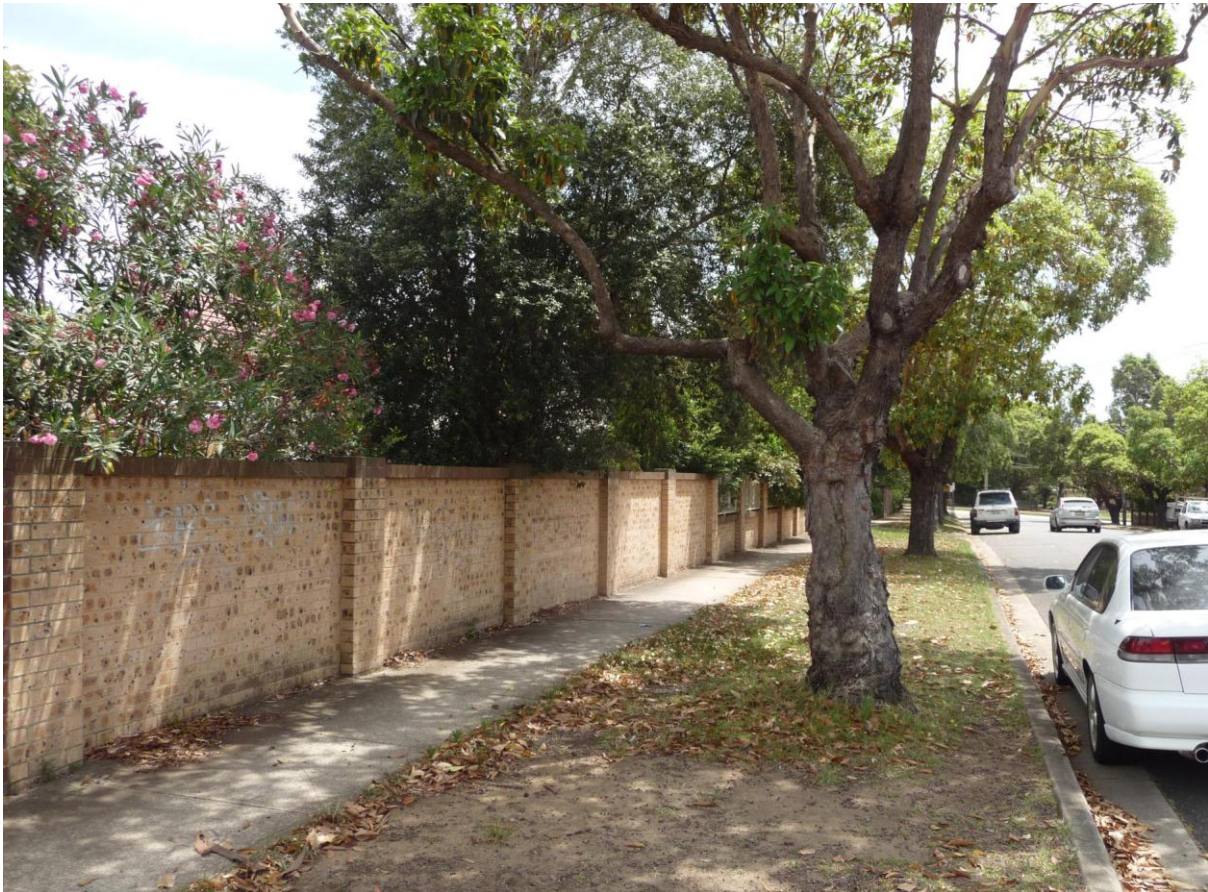
Trees 1 & 2 are street trees that will need a TPZ during the construction period to prevent soil compaction and mechanical damage from machinery. The 6m TPZ required is unrealistic considering how close the road and side walk is. A 2.5m SRZ would suffice.

2 x street trees to be retained

Trees 1 & 2 will require a TPZ of 2.5m. Refer to appendix B for TPZ requirements.

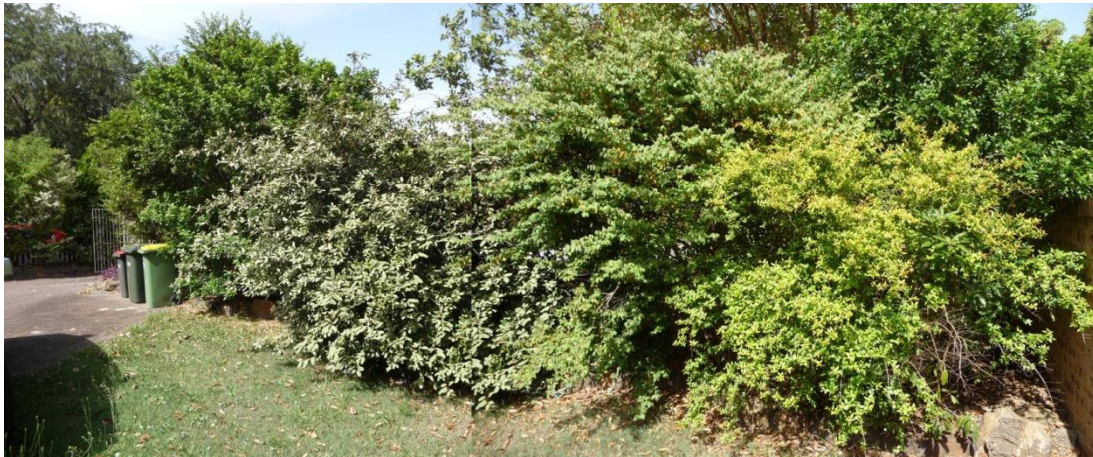
Trees 3-8, 11-14, 16-18 & 21-22 are to be removed and replaced as outlined in the landscape plan Drawing # 9082DA 1. All specimens seem to have been randomly planted and have been "let go". As a whole they look untidy and out of place.

Trees 3-8 inside front boundary wall

Trees 3-9, 11-14, 16-18 & 21-22 are to be removed. The large number of trees and shrubs replacing them will have a positive impact.

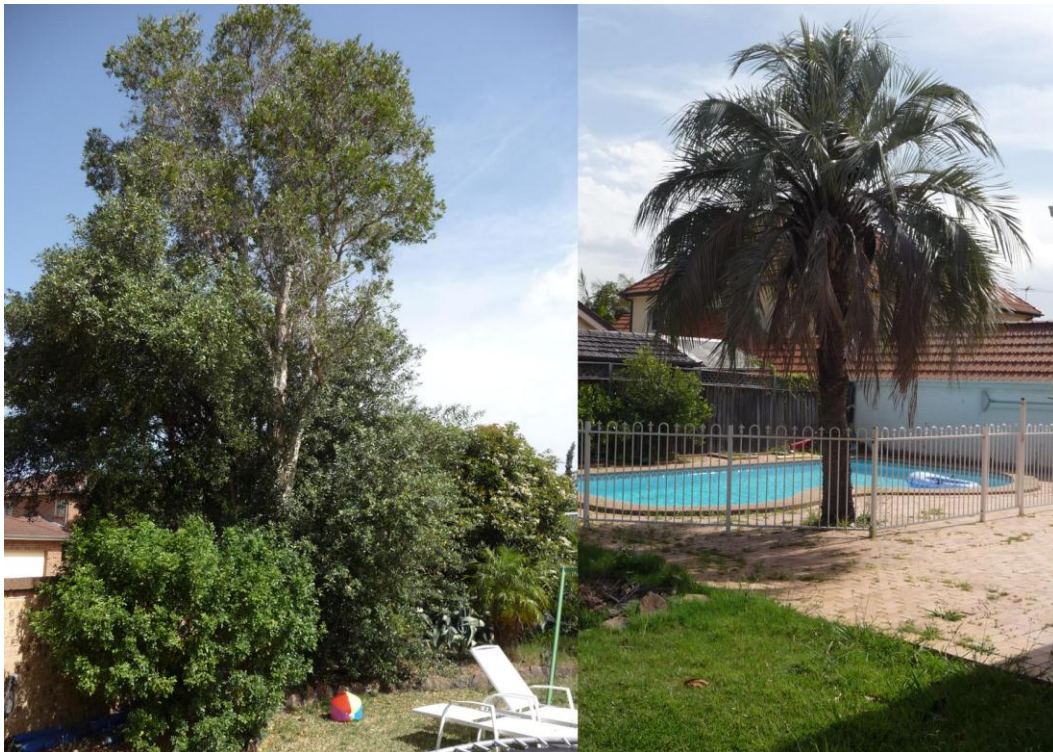
Tree 10 has been incorporated into the design and is to be retained. The current design shows a replacement boundary wall on South Street. Digging the footings for the wall will disturb and or sever more than 50% of the trees SRZ of 2.5m (as calculated using Australian standard AS 4970-2009 section 3.3.5)

The new pool will also encroach on the TPZ, but only by a small percentage.

Tree 19 is located outside the building footprint, but within the area proposed for paving. It is possible to retain, but this palm is considered undesirable for this area.

Left Tree 10 to be retained Right tree 19 to be removed

Tree 10 is to be retained The Original wall footing are to be used with the construction of the new boundary wall. The footings are to be retained 3.5m either side of the specimen.

If retention not possible due to condition of the current footings, then that section will have to be removed by hand. All roots that will be disturbed are to be located then inspected by an arborist then root pruning is to be carried out. All root pruning is to be done by an arborist (minimum AQF level 3).

TPZ of 3.5m applies. Please refer Appendix B for specifications.

Tree 19 This specimen is mathematically retainable, however it is recommended for removal due to its unsuitability of species for this location.
