## TREE MANAGEMENT REPORT

04.02.10

67 Watkins Street, Newtown

Hurley Building PLT LTD

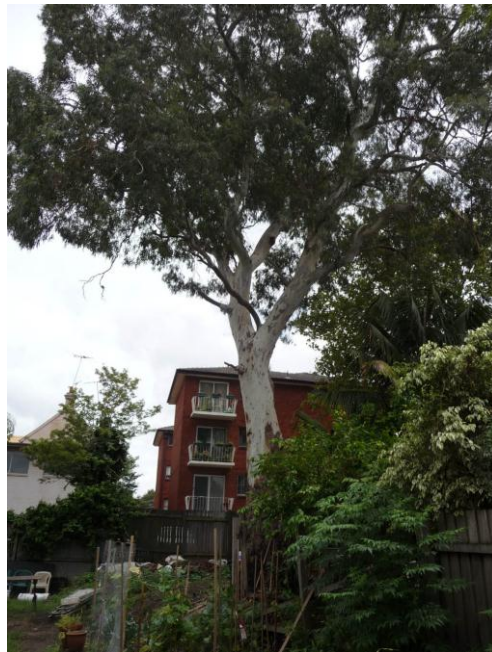
Shot of tree from No. 69 driveway

This tree is a mature/ over mature specimen. It has bracket fungi in 2 separate locations. 1 on the south side of the trunk approx. 1m from the ground. The second in the mid crown to the second order structural branch.

With medium volume epicomic growth and a high volume of small and large deadwood throughout the crown, it is apparent the tree is in a slow decline.

It is recommended that this tree is removed.

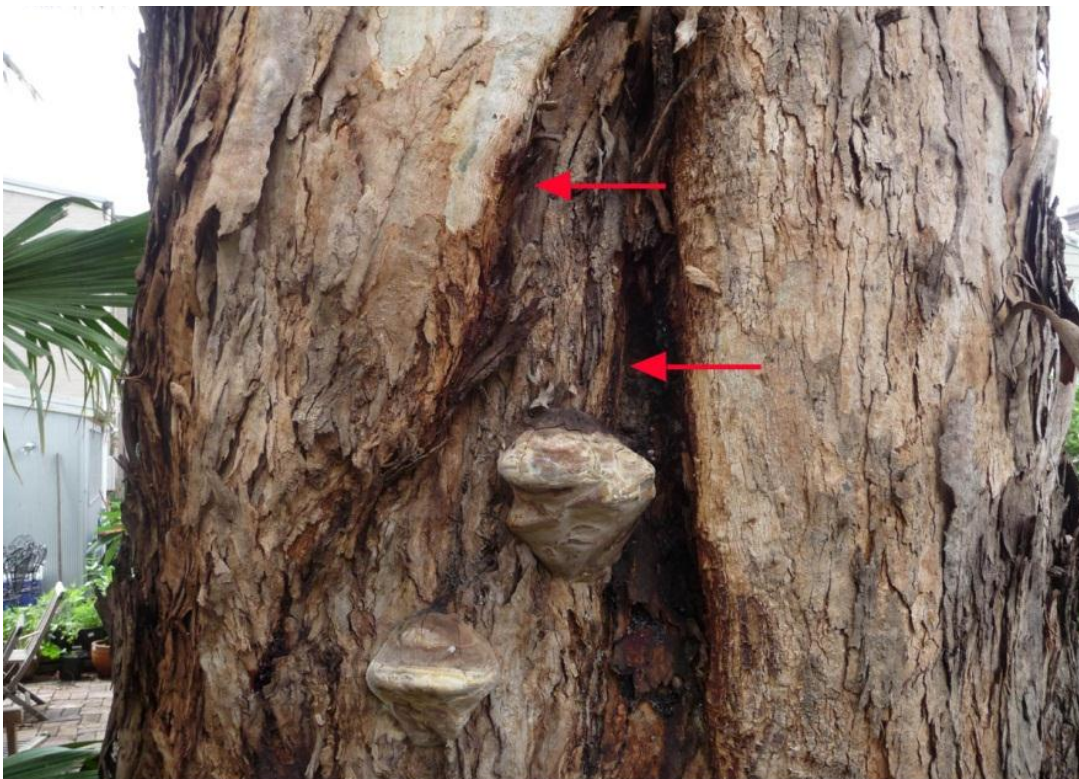
Its ability to heal itself is also receding as shown in the supporting picture below.

This pic shows 2 fungal brackets. Also shows trees initial attempt to heal (bottom arrow), then its second attempt to heal (top arrow)

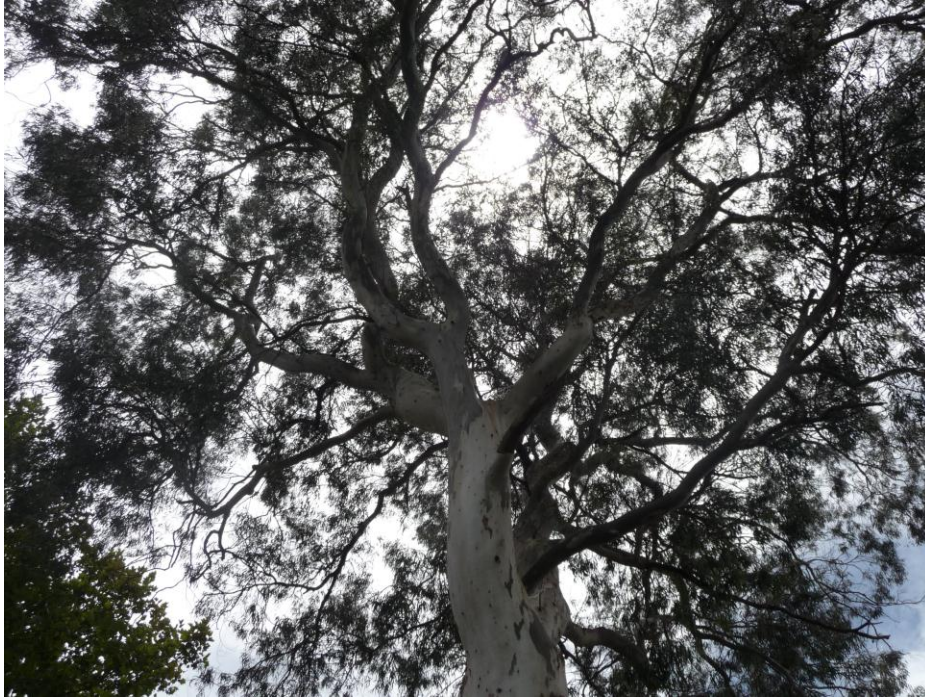
Pic looking into crown of tree showing vast amounts deadwood

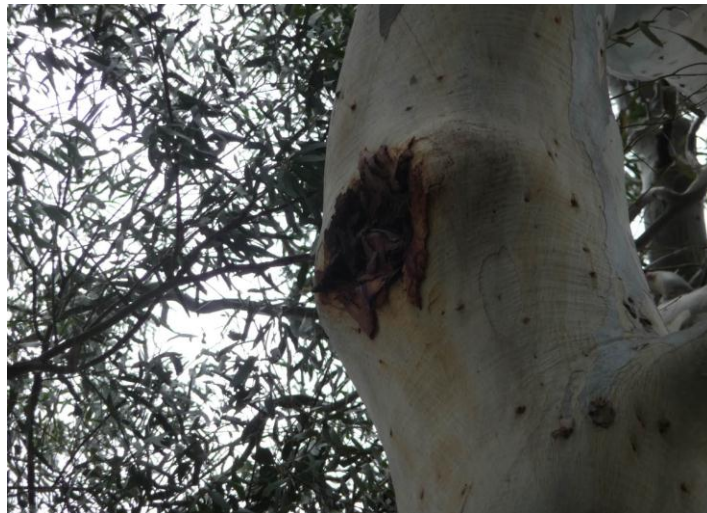
The Second fungal bracket found approx. 5m from the ground on the second order structural was not resistograph tested, but is of concern being found on another load bearing part of the structure.

Shows 2<sup>nd</sup> fungal bracket on second order structural branch

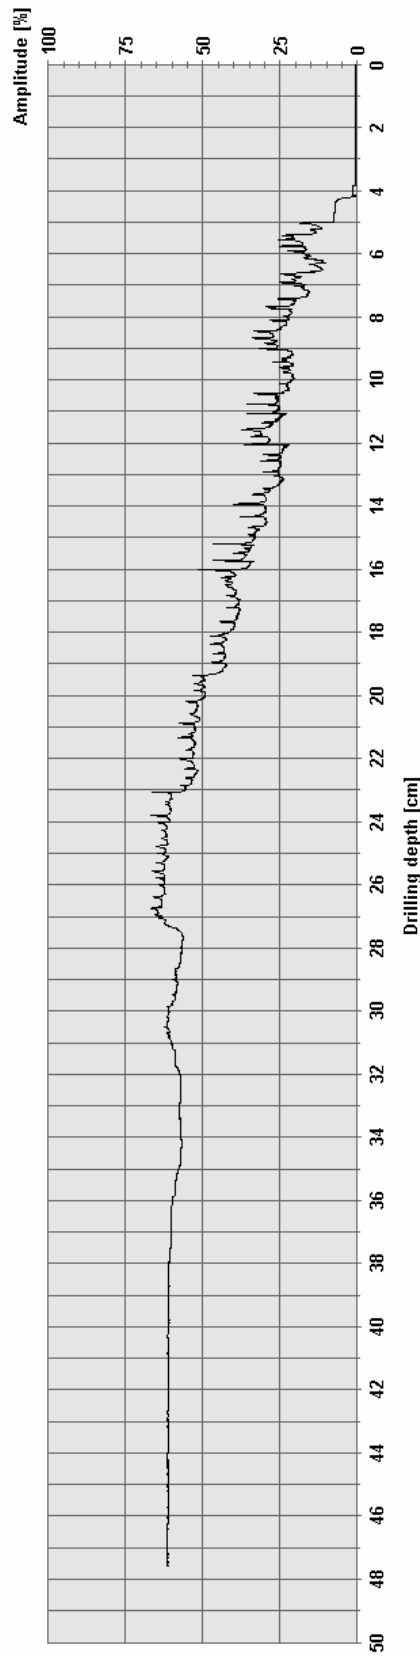
Drill No.1

Drill 1 - 0.58 or 59% soundwood

These three drills represent a horizontal breach from 3 opposing sides of the trees trunk at breast height. All three drills indicate that there is approx. 26cm of sound structural wood before you reach the decay at the center of the tree.

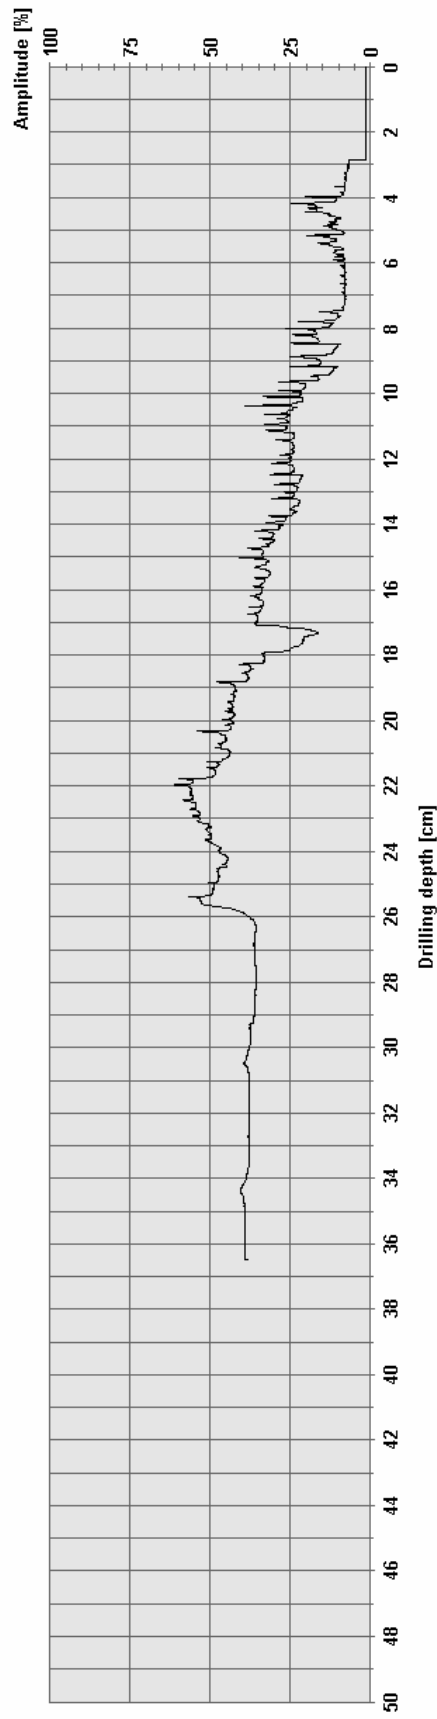
# Drill No.2

Drill 2 - 0.47 or 47% soundwood

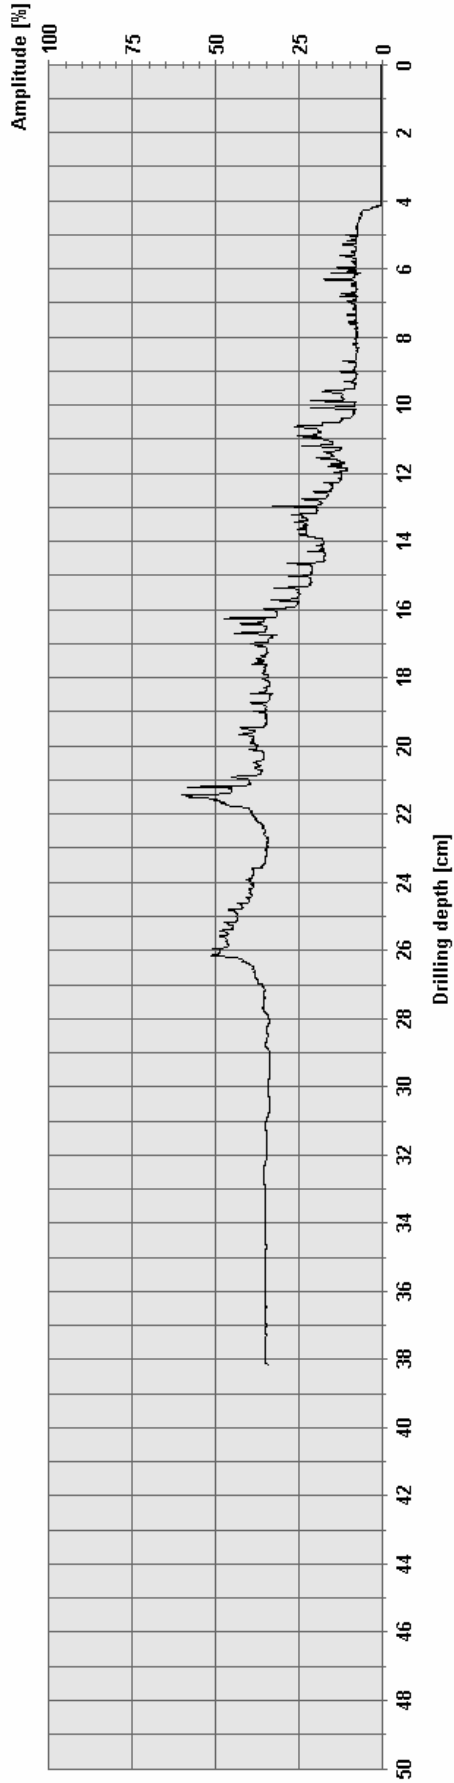
# Drill No.3

Drill3 - 0.43 or 43% soundwood
