TREE MANAGEMENT REPORT

17.10.09

1-3 Bligh Street, Burwood Heights

Urban Apartments

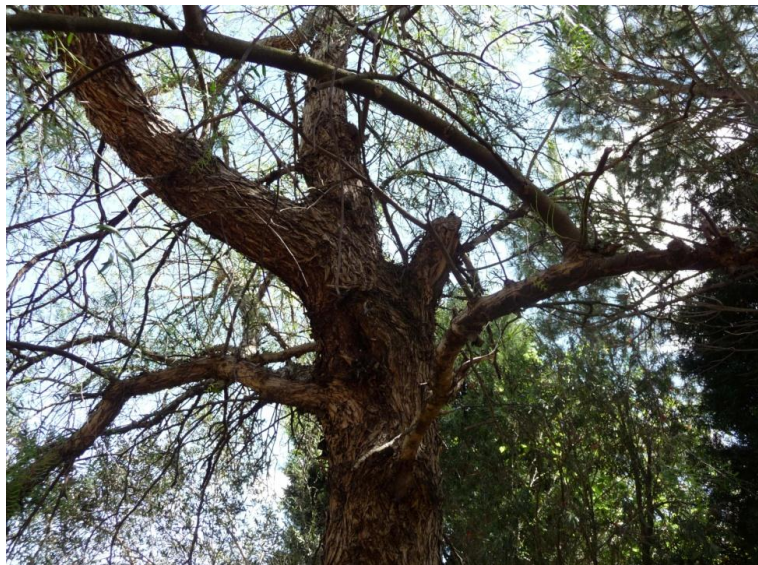
Specimens 3 and 4 located at the rear of the property are in very poor condition due to years of neglect, poor pruning practices and soil compaction. Specimen 3 *Shinus molle* *Peppercorn tree* is an over mature tree showing signs of stress. It has epicormic shoots from base to crown and shows signs of previous branch failures.

Specimen 3 Peppercorn tree showing poor growth and epi shoots

I recommend that trees 3 and 4 are removed.

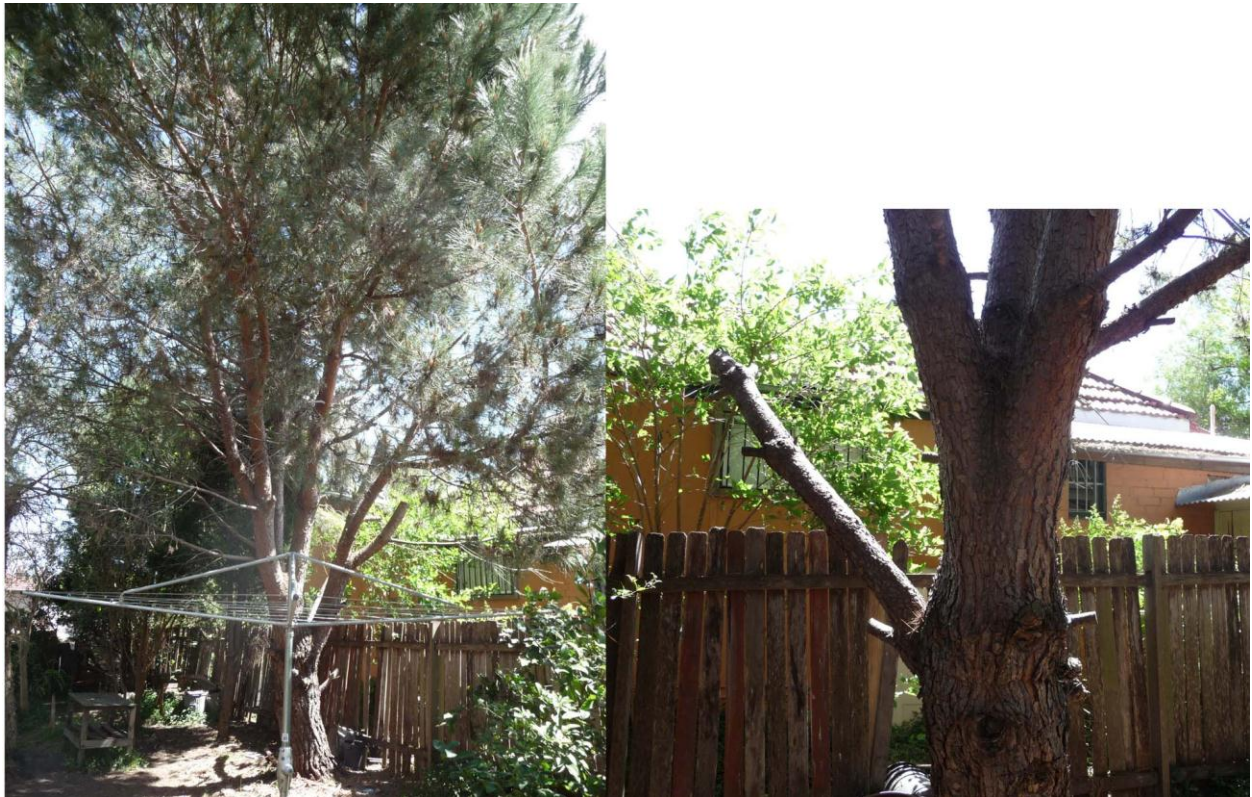
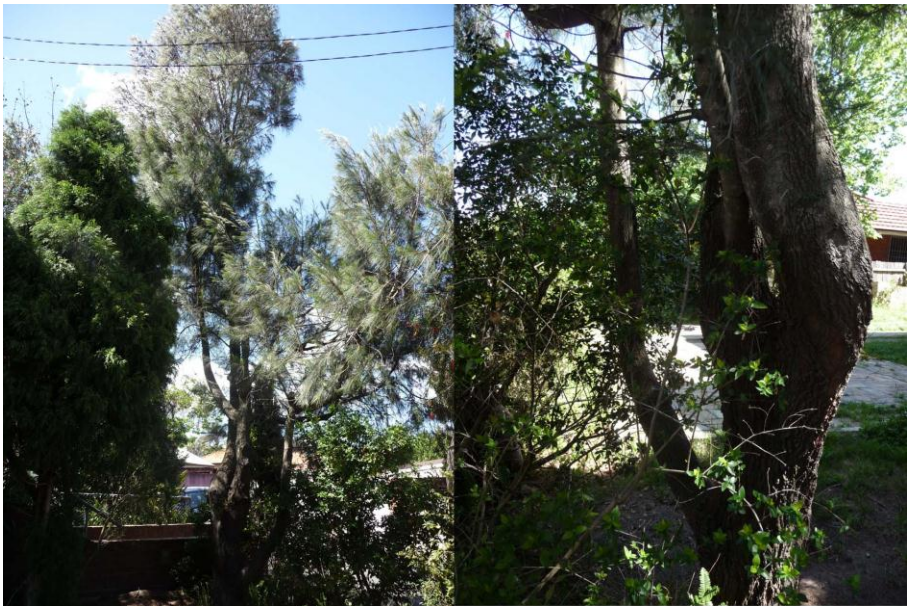
Specimen 6 the *Casuarina glauca* seems to be in fair health, but has a very poor habit. It is still a very young specimen, but due to its placement is growing directly into service lines. This tree was not trained into a single main leader, but has several twisting leaders. In time this tree will be an issue.

Left. Specimens 5 & 6. Right. casuarinas growth pattern

I will allow specimens 2, 6 and 8 to be removed due to the fact that they are very young and on the provision that they are directly replaced in the gardens of the new development

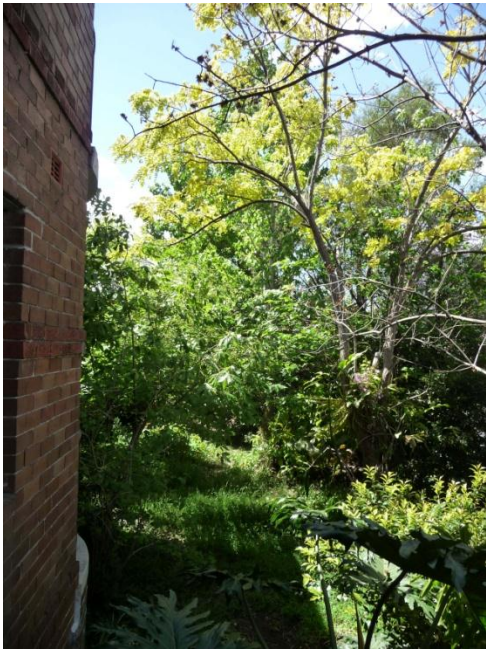
Specimens 2, 7 and 8 all seem to be in good health with good growth patterns and are structurally sound. They show no signs of stress or insect activity. All specimens are juvenile and fall just inside TPO approval requirements.

Specimen 8 Golden robinia
